Division 6 Asbestos Report
Holdsworth House
137 Holdsworth Road
North Bendigo VIC 3550

SSPL Job No 210307-07

Division 6 Asbestos Report. Holdsworth House. 137 Holdsworth Road, North Bendigo VIC 3550.

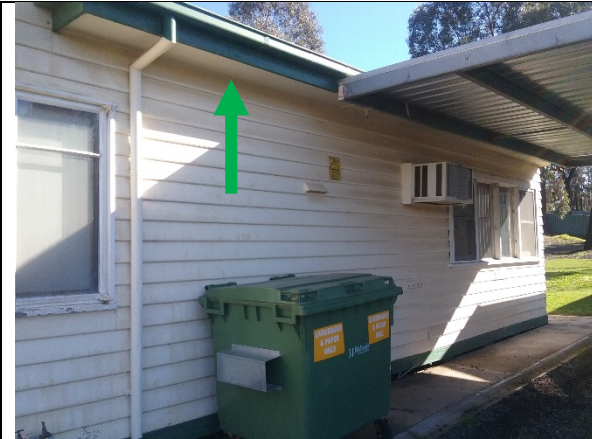
Photo 2:
No asbestos detected in sample 1-270721. Cement sheet eaves of House.

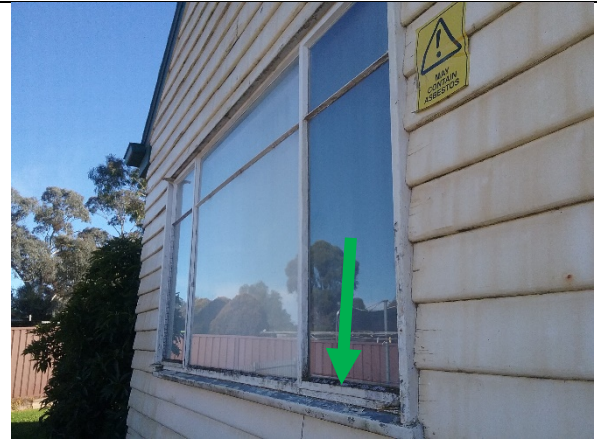
Photo 3:
No asbestos detected in sample 2-270721. Window putty of House.

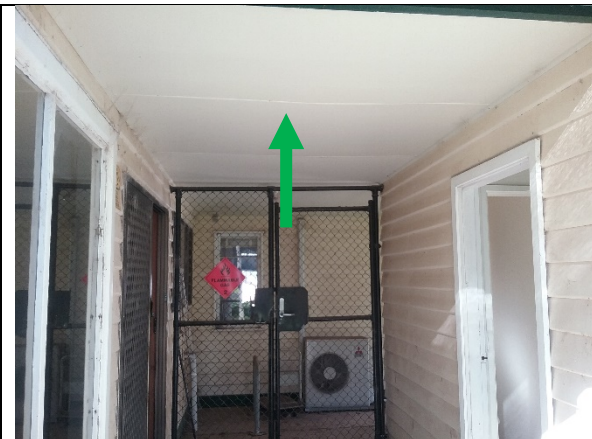
Photo 4:
No asbestos detected in sample 3-270721. Cement sheet ceiling of Verandah.

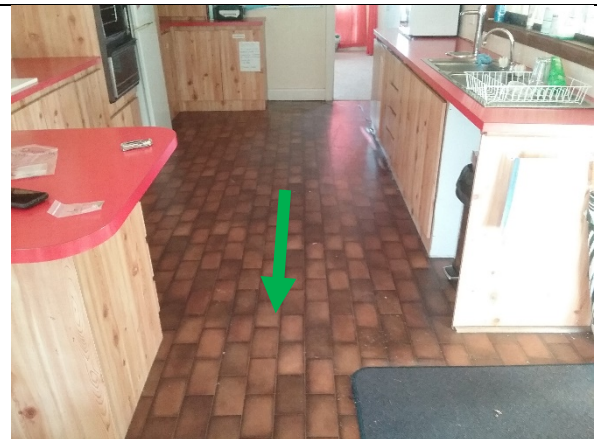
Photo 5:
No asbestos detected in sample 4-270721. Vinyl sheet on timber floor of Kitchen/Dining.

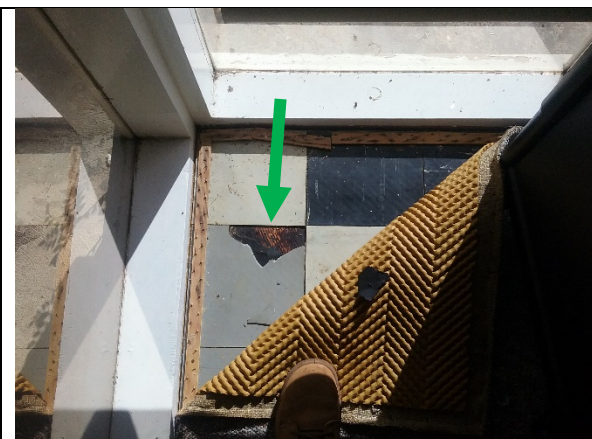
Photo 6:
No asbestos detected in sample 5-270721. Vinyl tile beneath carpet floor of Kitchen/Dining.

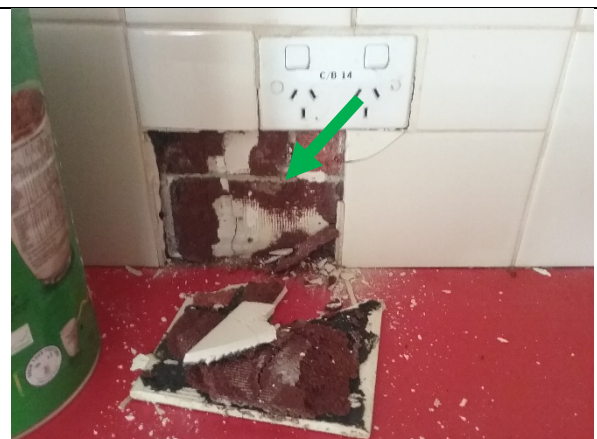
Photo 7:
No asbestos detected in sample 6-270721. Ceramic tile adhesive of splash back in Kitchen/Dining.

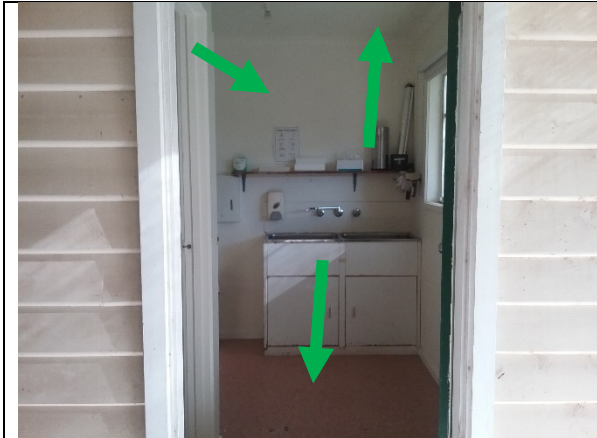
Photo 8:
No asbestos detected in sample 7-270721, 8-270721 & 9-270721. Cement sheet ceiling & walls and vinyl sheet floor of Laundry/Toilet.

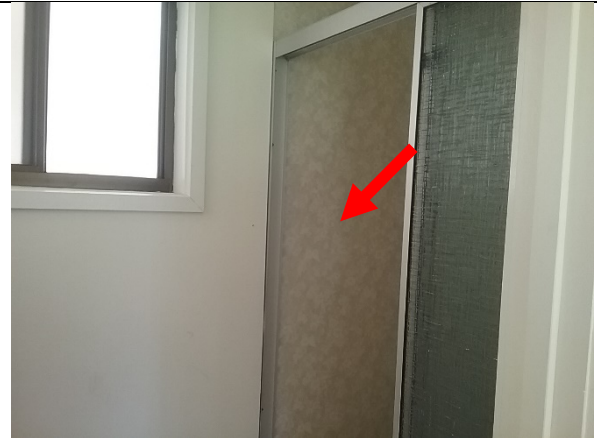
FRIABLE ASBESTOS				
Building	Location	Surface	Material	Priority
	No friable asbestos identified			
NON-FRIABLE ASBESTOS				
Building	Location	Surface	Material	Priority
House	Laundry/Toilet	Shower	Tilux	3
INACCESSIBLE AREAS				
Building	Location	Surface	Material	Priority
	No inaccessible locations identified

Photo 9:
Tilux surfaces of shower in Laundry/Toilet visually identified as asbestos.

House	all office spaces	Ceiling	Plaster						No	
		House	all office spaces	Wall	Plaster						No	
		House	all office spaces	Floor	Carpet on Timber						No	
		House	bathroom/toilet	Ceiling	Plaster						No	
		House	bathroom/toilet	Wall	Plaster						No	
		House	bathroom/toilet	Floor	Vinyl Sheet						No	
		House	bathroom/toilet	bath hub	Ceramic Tile on cement						No	
		House	bathroom/toilet	splashback	Ceramic Tile on cement						No	
		House	bathroom/toilet	shower	Ceramic Tile on cement						No	
8	7-270721	House	laundry/toilet	Ceiling	Cement Sheet				Sample tested negative for asbestos.		No	
Refer to 8	8-270721	House	laundry/toilet	Wall	Cement Sheet				Sample tested negative for asbestos.		No	
Refer to 8	9-270721	House	laundry/toilet	Floor	Vinyl Sheet				Sample tested negative for asbestos.		No	
9	Visual ID	House	laundry/toilet	shower	Tilux	Stable	Yes	No	Tilux Visually Identified as asbestos. Engage a licensed asbestos removalist prior to works which may cause disturbance.	3	Asbestos	5
