Division 5 Asbestos Report
Headspace
78-80 Pall Mall
Bendigo VIC 3550

SSPL Job No 210307-02

Division 5 Asbestos Report. Headspace, 78-80 Pall Mall, Bendigo VIC 3550.

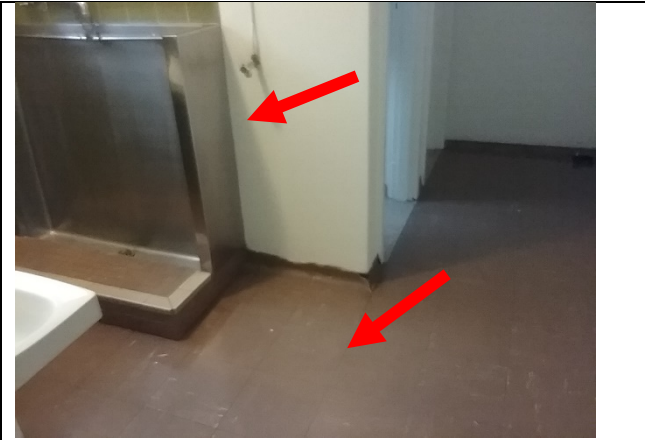
Photo 2:
Asbestos detected in representative sample 1-230721. Vinyl tile floor in male toilet. Possible cement sheet behind urinal. Assume asbestos is present until determined otherwise.

Main	Studio and multipurpose room	Ceiling	Plaster						No	
		Main	Studio and multipurpose room	Wall	Plaster						No	
		Main	Studio and multipurpose room	Floor	Carpet on concrete						No	
		Main	Courtyard	Wall	Brick						No	
		Main	Courtyard	Floor	Concrete						No	
		Main	Male toilets	Ceiling	Plaster						No	
		Main	Male toilets	Wall	Masonry						No	
2	Refer to 1-230721	Main	Male toilets	Floor	Vinyl tile	Stable	Yes	No	Representative sample tested positive for asbestos. Maintain in good condition. Indicate presence of ACM with labelling. Review Asbestos Register and engage a licensed asbestos removalist (Class A or Class B) prior to refurbishment or demolition.	3	Asbestos	10

Photo	Sample	Building	Location	Surface	Material	Condition	Readily accessible	Friable	Comments / Likelihood of disturbance	Hazard Priority*	Hazardous Material	Approx. Qty (m ²)
2		Main	Male toilets	Urinal					Possible cement sheet behind urinal. No access behind urinal without using destructive methods. Assume asbestos is present until determined otherwise.	4	Asbestos	
		Main	Male toilets	Splash back	Ceramic tile				Possible cement sheet behind/beneath ceramic tiles. No access without using destructive methods. Assume asbestos is present until determined otherwise. Engage an asbestos consultant prior to works which may cause disturbance.	4	Asbestos	
		Main	Rear Office x2	Ceiling	Plaster						No	
		Main	Back office room x2	Wall	Plaster						No	
		Main	Back office room x2	Floor	Carpet on concrete						No	
		Main	Board room	Ceiling	Timber						No	
		Main	Board room	Wall	Timber						No	
		Main	Board room	Floor	Carpet on Concrete						No
