Division 5 Asbestos Report

PCP Building

127 King Street

12th August 2021

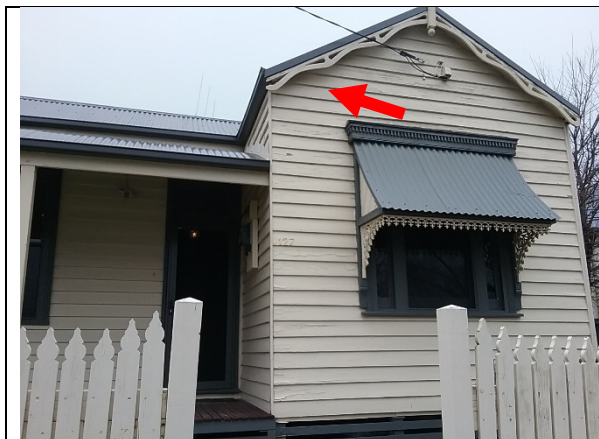
Photo 1:
No access to eaves due to fall hazard. Assume asbestos is present until determined otherwise.

A Division 6 Audit should be carried out on any inaccessible areas prior to works which may cause disturbance.

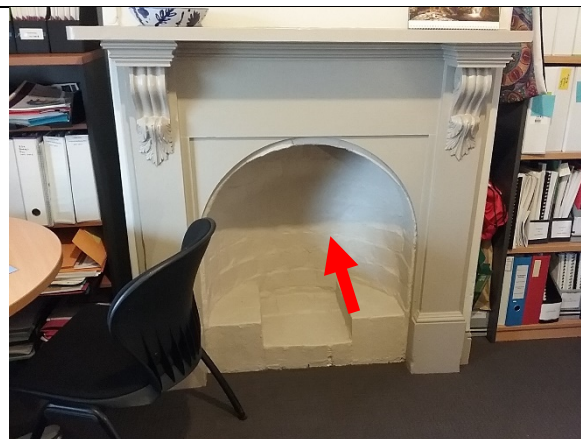
Photo 2:
No access inside office fireplace at the time of the audit. Assume asbestos is present until determined otherwise.

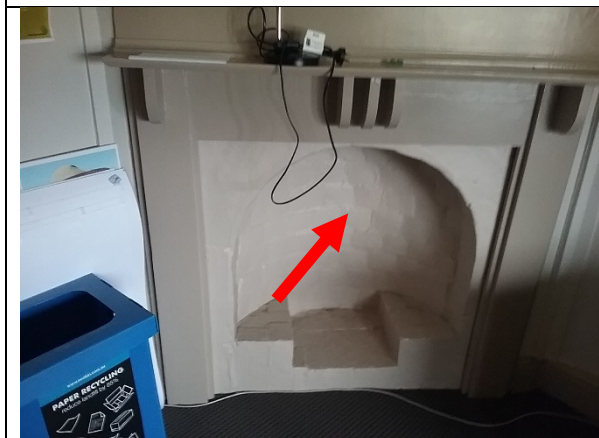
Photo 3:
No access inside office fireplace at the time of the audit. Assume asbestos is present until determined otherwise.

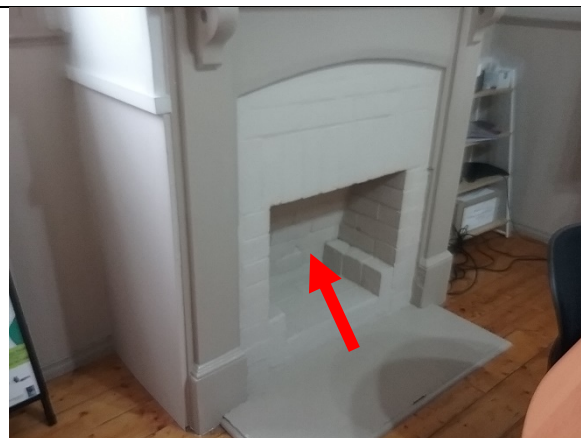
Photo 4:
No access inside hallway and dining room fireplace at the time of the audit. Assume asbestos is present until determined otherwise.

4		House	Hallway and Dining Room	Fireplace					No access inside fireplace at the time of the audit. Assume asbestos is present until determined otherwise. Engage an asbestos consultant prior to works which may cause disturbance.	4	Asbestos	
		House	Kitchen	Ceiling	Plaster							
		House	Kitchen	Wall	Plaster							
		House	Kitchen	Floor	Vinyl sheet				Possible AC materials beneath modern vinyl sheet. Assume asbestos is present until determined otherwise. Engage an asbestos consultant prior to works which may cause disturbance.	4	Asbestos	
5		House	Kitchen	Fireplace					No access inside fireplace at the time of the audit. Assume asbestos is present until determined otherwise. Engage an asbestos	4	Asbestos

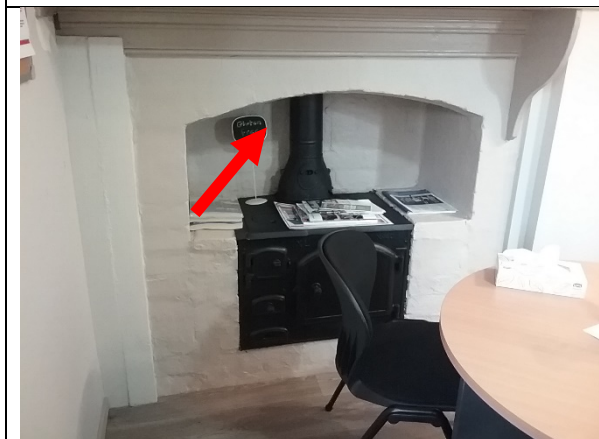
Photo 5:
No access inside kitchen fireplace at the time of the audit. Assume asbestos is present until determined otherwise.
