Division 5 Asbestos Report
Residential AOD Withdrawal Unit
137 Holdsworth Road
North Bendigo VIC 3550

SSPL Job No 210307-08

Division 5 Asbestos Report. Residential AOD Withdrawal Unit. 137 Holdsworth Road, North Bendigo 3550.

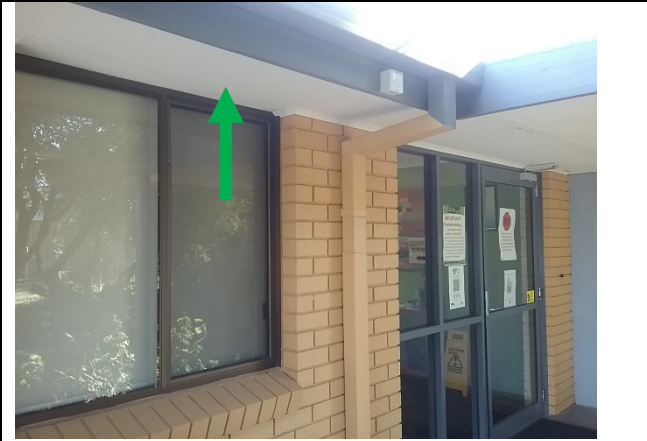
Photo 2:
No asbestos detected in sample 1-270721. Cement sheet eaves
of Main building.
