Division 5 Asbestos Report
3 Seymoure Street
Eaglehawk VIC 3556

SSPL Job No 210307-01

Division 5 Asbestos Report. 3 Seymoure Street, Eaglehawk VIC 3556.

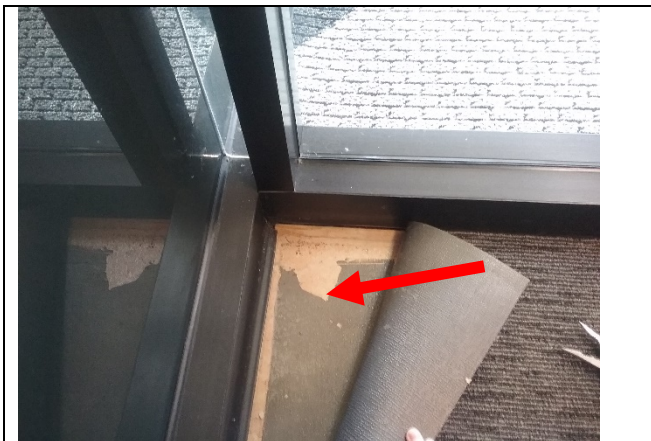
Photo 2:

No access beneath ceramic tiles in reception. Possible cement sheet beneath ceramic tiles. Assumes asbestos is present until determined otherwise.

| Photo | Sample | Building | Location | Surface | Material | Condition | Readily accessible | Friable | Comments / Likelihood of disturbance | Hazard Priority* | Hazardous Material | Approx. Qty (m ²) |
|---|---|---|---|---|---|---|---|---|---|---|---|---|
| 2 | | Main | Reception | Floor | Carpet on Ceramic tile | | | | Possible cement sheet behind/beneath ceramic tiles. No access without using destructive methods. Assume asbestos is present until determined otherwise. Engage an asbestos consultant prior to works which may cause disturbance. | 4 | Asbestos | |
