RE: Asbestos Sample Identification Results for Headspace, 78 – 80 Pall Mall, Bendigo VIC 3550

Headspace – 78-80 Pall Mall, Bendigo VIC 3550

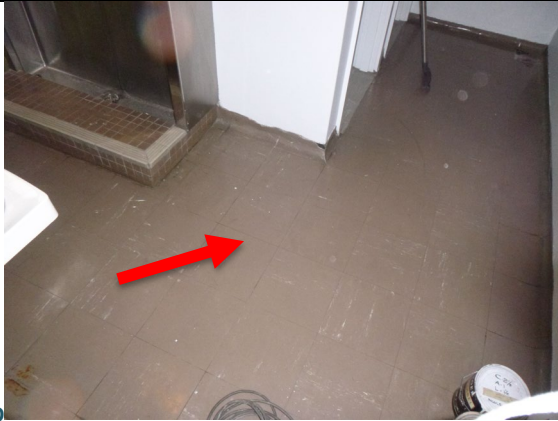
Sample No	Location/ Surface	Material	Friable	Approx. Quantity (m ²)	Comments	Asbestos Detected
1-230721	Staff toilet / floor	Vinyl tile	No	10	Vinyl tile with black adhesive. Sample tested positive for asbestos. Maintain in good condition. Indicate presence of ACM with labelling. Review Asbestos Register and engage a licensed asbestos removalist (Class A or Class B) prior to refurbishment or demolition.	Yes
2-230721	Staff toilet / floor	Adhesive			Sample tested negative for asbestos.	No

D
Photo 349:
Asbestos detected in sample 01-230721. Vinyl tile floor in staff toilet.

Client ID	Sample Size	Description	Asbestos
1-230721	60x40x3mm	Brown vinyl layer	Chrysotile
2-230721	15x5x1mm	Black layer	No

Sample tested positive for asbestos. Maintain in good condition. Indicate presence of ACM with labelling. Review Asbestos Register and engage a licensed asbestos removalist (Class A or Class B) prior to refurbishment or demolition.

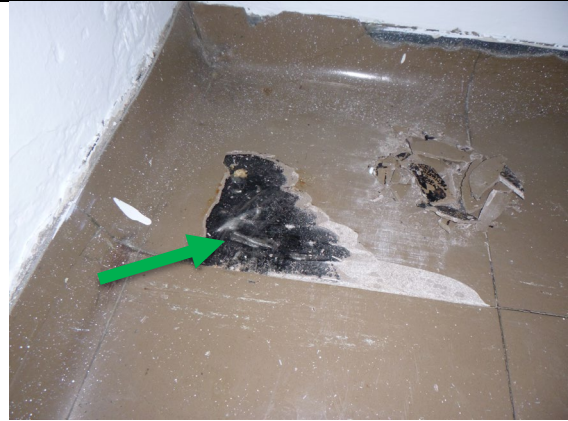
Photo 350:
No asbestos detected in sample 2-230721. Black adhesive beneath vinyl tiles in staff toilet.
